NATIONAL DRY OUT

PAST PERFORMANCE

Alabama Department of Transportation
Mold Remediation and Document Recovery
October 2012 and February 2013

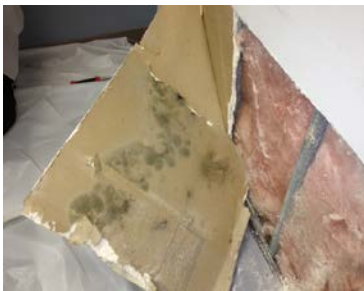
Once the areas were completely empty of all contents the drying and clean up began. This process included applying a hydrogen peroxide based mold remover that breaks down the mold spores at the cell level. This product was dried along with the structure using a heat system and dehumidifies. No air movers were used due to the mold growth. After 3 days all areas were dried down to meet and exceed the standards set by the EPA and IICRC. This was followed by a complete HEPA vacuuming and wet wipe down of the entire structure.

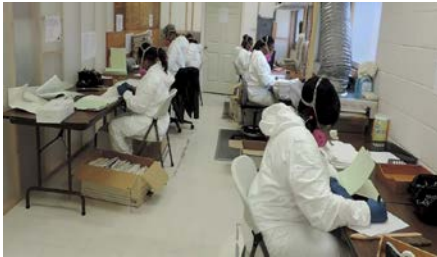
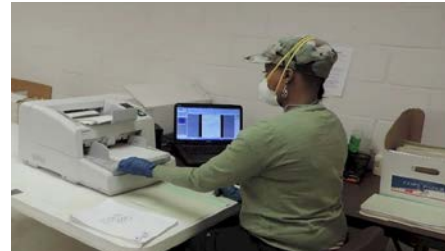
As the pictures indicate, this effort required the drying and restoration of water-damaged documents, as well as digitizing them to generate an electronic document that could be stored in a manner impervious to such damage in future. National Dry Out restored and digitized 1,230,215 maps and over 5,530,000 documents. This project lasted roughly 22 months. Once all documents were reviewed for quality by the Department of Transportation we were instructed to destroy all the documents.

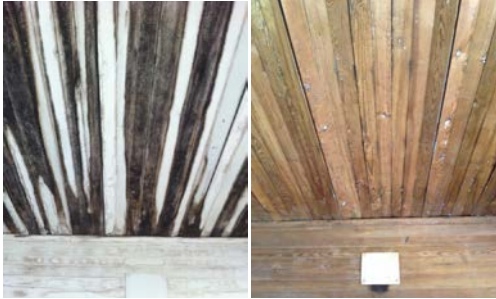
Before

After

The University agreed and the process began. As each room was completely pressure washed a heat drying system was setup and monitored to ensure the drying process meet the standards set by the IICRC. As each room was cleaned and dried we checked the make sure the areas were we used moisture meters and thermal imaging. The complete project took 21 days to complete. Post testing was completed in each area to ensure the building meets and or exceeds the standards set by the EPA and IICRC.
