# NATIONAL DRY OUT

## PAST PERFORMANCE

**Alabama Department of Transportation**  
**Mold Remediation and Document Recovery**  
**October 2012 and February 2013**

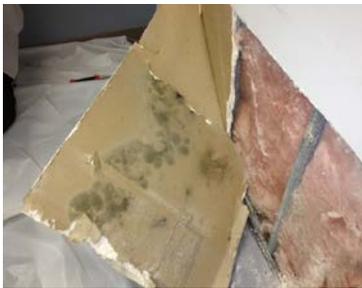
Once the areas were completely empty of all contents the drying and clean up began. This process included applying a hydrogen peroxide based mold remover that breaks down the mold spores at the cell level. This product was dried along with the structure using a heat system and dehumidifies. No air movers were used due to the mold growth. After 3 days all areas were dried down to meet and exceed the standards set by the EPA and IICRC. This was followed by a complete HEPA vacuuming and wet wipe down of the entire structure.

Post testing was performed in all areas to ensure the building was safe for all visitors and employees.

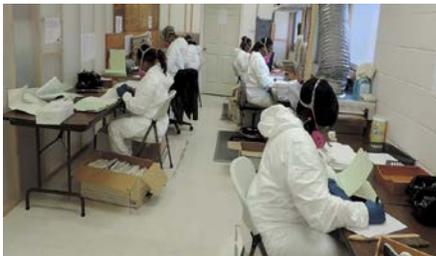
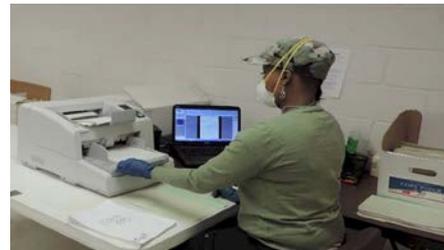
As the pictures indicate, this effort required the drying and restoration of water-damaged documents, as well as digitizing them to generate an electronic document that could be stored in a manner impervious to such damage in future. National Dry Out restored and digitized 1,230,215 maps and over 5,530,000 documents. This project lasted roughly 22 months. Once all documents were reviewed for quality by the Department of Transportation we were instructed to destroy all the documents.
